PASSAIC RIVER BASIN
SLIPPERY ROCK BROOK, PASSAIC COUNTY
NEW JERSEY

BARBOURS POND DAM NJ 00241

PHASE 1 INSPECTION REPORT
NATIONAL DAM SAFETY PROGRAM

MARCH 1981

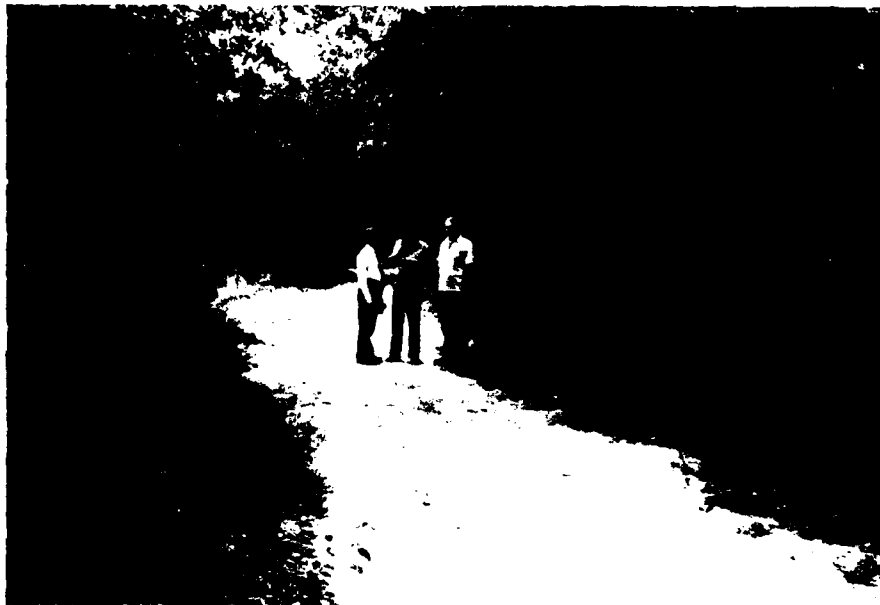
August, 1980
View of Crest from Right Abutment

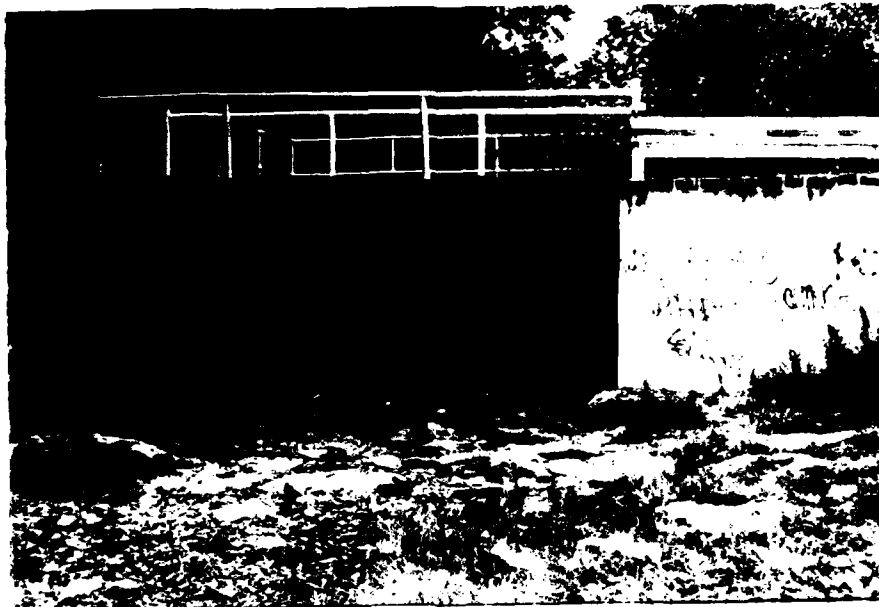
The only operational facility at this dam is the 12-inch diameter drain, which apparently has not been opened in recent years. Moreover, the valve must be considered inoperative until such time as the gate wheel is replaced and the valve is tested for functionability. It does not appear that this dam component is included among the general maintenance tasks performed by Park Commission Personnel.

View of Principal Outlet
